**DEKRA**
Test Report

Product : Empty enclosure

Type(s) : Teos Series (plus+ / standard)

Subject : Degree of protection provided by enclosure, IP65

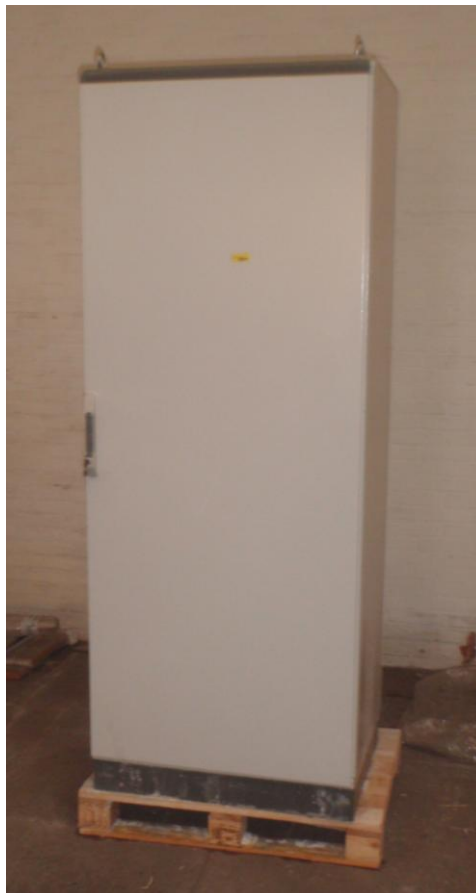
3 Object identification

Trademark : Tekpan
Type : Teos Series (plus+ / standard)
Dimensions : Height: 2100 mm
Width: 800 mm
Depth: 600 mm
Material : Sheet steel
Number of samples tested : 1

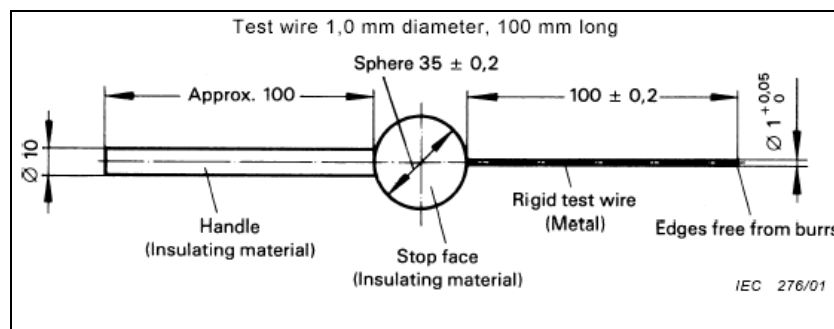
The access probe as shown in figure on this page was pushed against any openings of the enclosure with a force of $1\text{N} \pm 10\%$

The full diameter of the access probe did not penetrate through an opening of the enclosure and adequate clearance was kept.

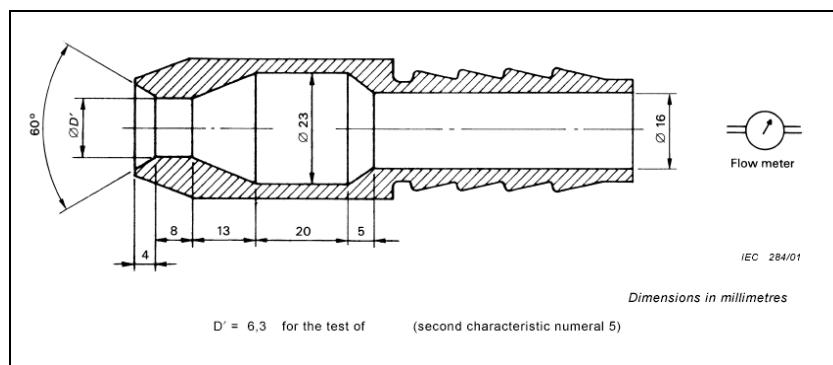
The test was made by spraying the enclosure from all practicable directions with a stream of water from a standard test nozzle as shown in figure on this page

- internal diameter of the nozzle: 6,3 mm;
- delivery rate: 12,5 l/min \pm 5 %;
- water pressure: to be adjusted to achieve the specified delivery rate;
- core of the substantial stream: circle of approximately 40 mm diameter at 2,5 m distance from nozzle;
- test duration per square meter of enclosure surface area likely to be sprayed: 1 min;
- minimum test duration: 3 min;
- distance from nozzle to enclosure surface: between 2,5 m and 3 m.

After the test there was no ingress of water.

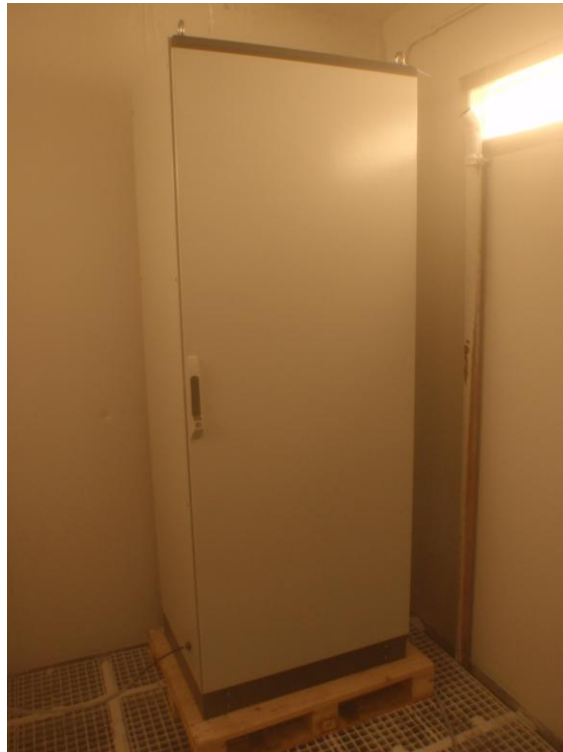
Photo 1: Inside dust chamber before IP6X test

The enclosure under test was supported inside the test chamber and the pressure inside the enclosure was maintained below the surrounding atmospheric pressure by a vacuum pump.

The object of the test was to draw into the enclosure, by means of depression, a volume of air 80 times the volume of the sample enclosure tested without exceeding the extraction rate of 60 volumes per hour. The depression did not exceed 2 kPa (20 mbar) on the manometer.

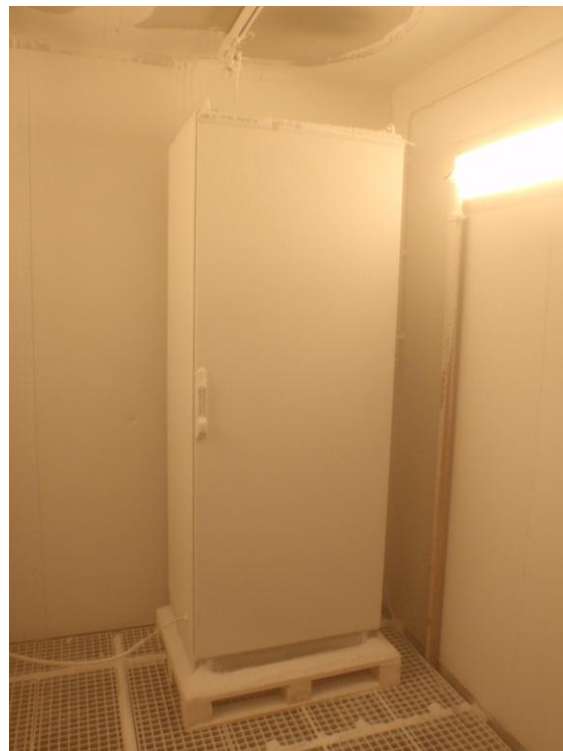
Photo 2: Inside dust chamber after IP6X test

After the test there was no dust found inside the tested sample.

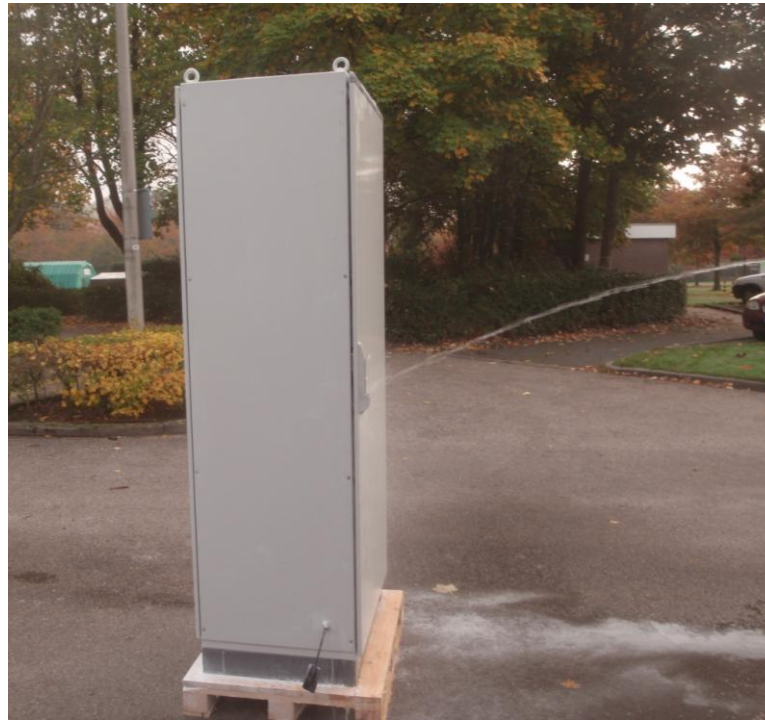
Photo 3: During IPX5 test

The duration of the test was 6,5 minutes.
